ANNUAL REPORT FOR 2015

Bald Creek Site #3 Mitigation Site
Yancey County
TIP No. R-2518B
COE Action ID: SAW-2007-2197-357/300
DWR #: 20071134

Prepared By:
Natural Environment Section & Roadside Environmental Unit
North Carolina Department of Transportation
November 2015

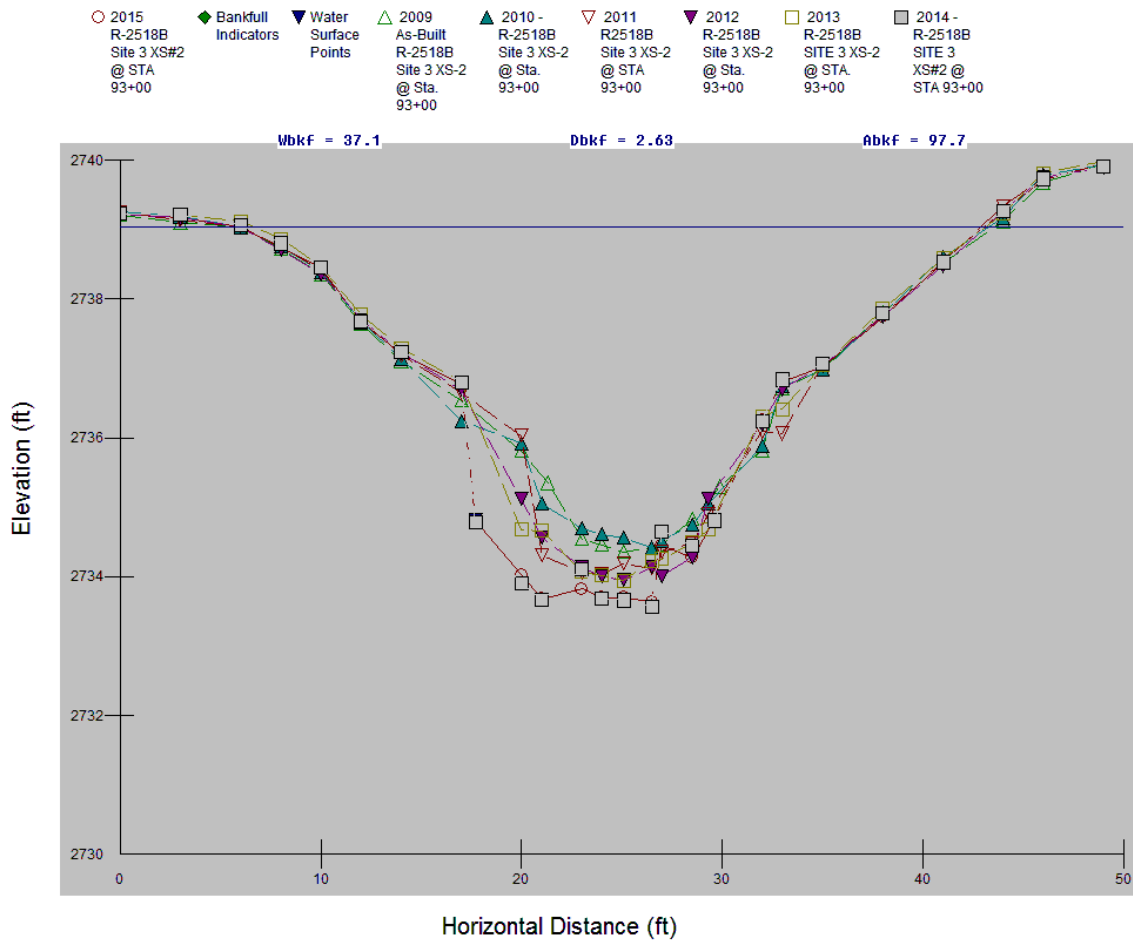
R-2518B Site 3 XS#2 @ STA 93+00

Based on comparisons of the As-Built to the monitoring data, all of the cross sections appear stable with little or no active bank erosion. Graph of the Cross Section #2 is presented in Appendix A. Future survey data will vary depending on actual location of rod placement and alignment; however, this information should remain similar in appearance.

Site #3: Cross-Section #2 (Pool) Abbreviated Morphological Summary*						
	2010	2011	2012	2013	2014	2015
Bankfull Cross Sectional Area (ft ²)	86.6	90.04	91.01	93.36	97.78	97.66
Maximum Bankfull Depth (ft.)	4.61	5.0	5.09	5.18	5.5	5.4
Bankfull Mean Depth (ft.)	2.32	2.44	2.45	2.49	2.63	2.63
Bankfull Width (ft.)	37.26	36.9	37.18	37.49	37.22	37.11

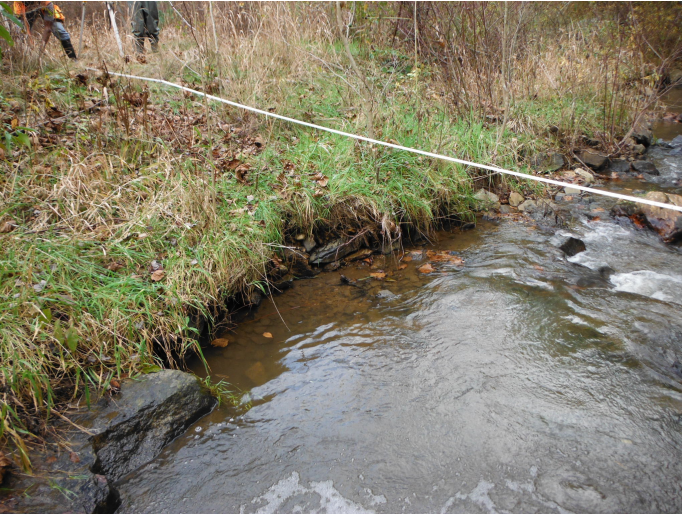
Cross Section #2 left bank remains stable

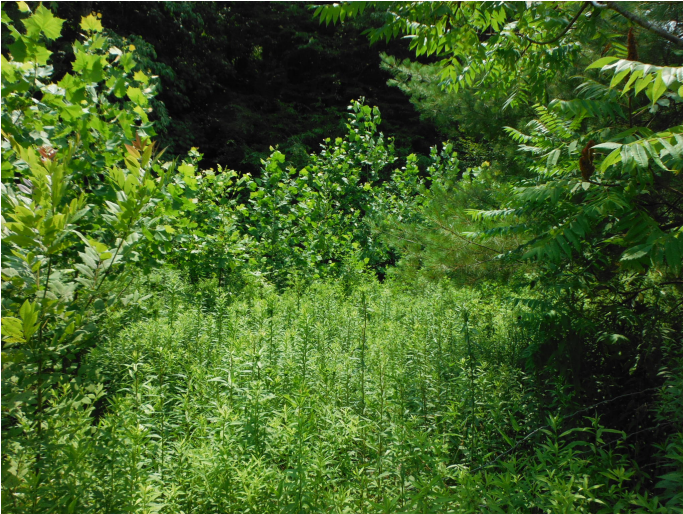
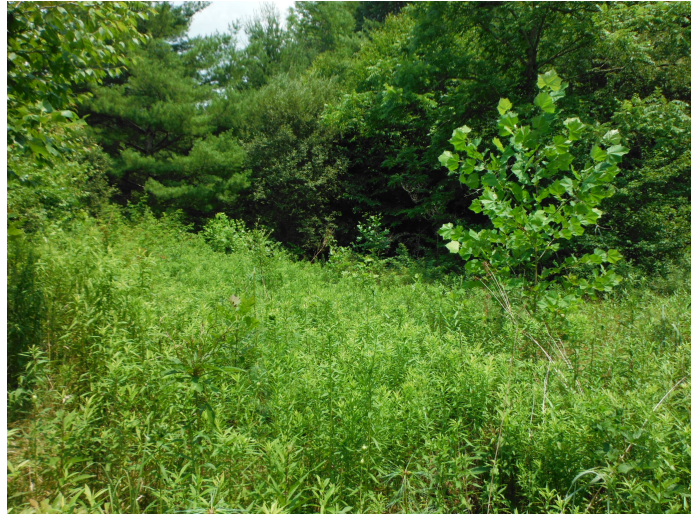
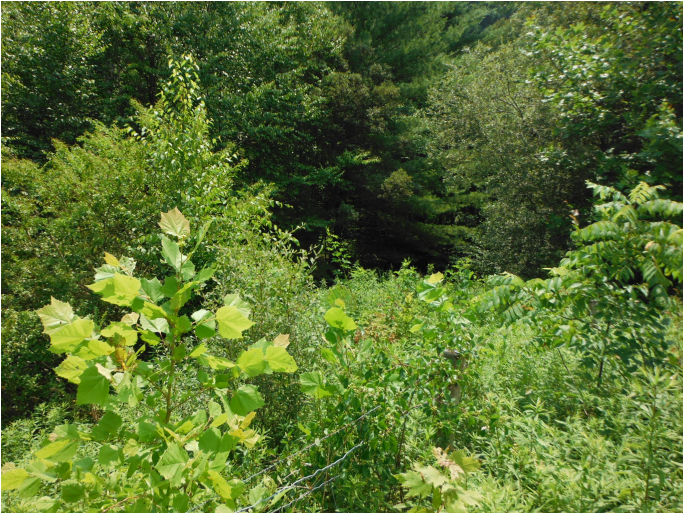
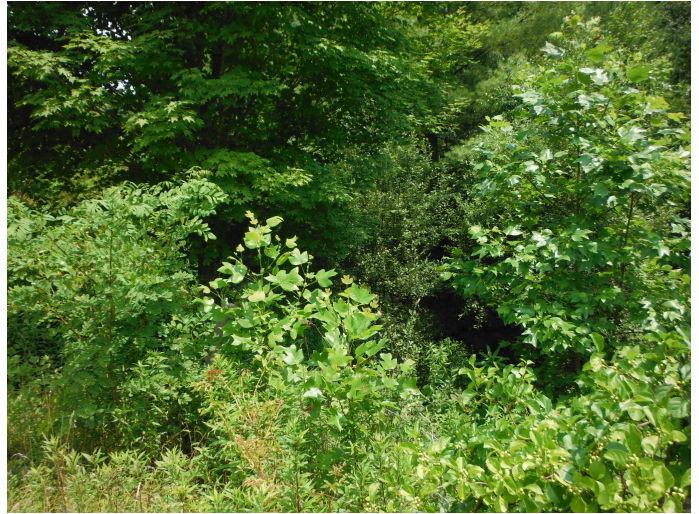
Vegetation Overview Photo

Streambank & Buffer Vegetation: The streambank reforestation was completed in March 2012. The Year 4 vegetation monitoring evaluation noted: Type I: Black Willow, Silky Dogwood and Type II: Sycamore, Green Ash, Tulip Poplar, and White Oak were surviving at the time of the monitoring evaluation.
